Martin Marietta Emergency Assistance

Auld's Cove, NOVA SCOTIA
Demolition

DESCRIPTION
Emergency services to bring rock quarry wharf load out facility back into operation after steel sheet pile wharf failure.

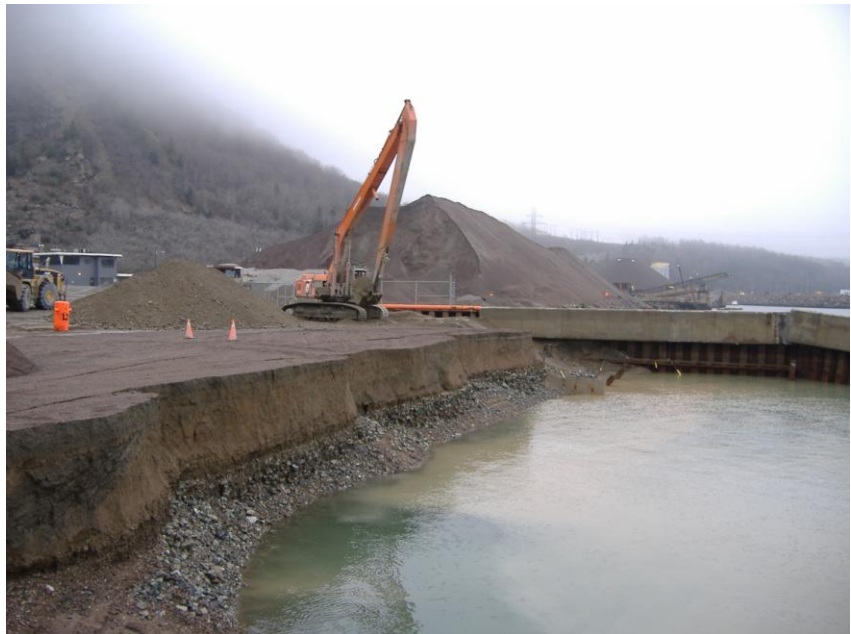
INSTALLATION METHOD
The wharf backfill was removed from the wharf face to remove pressure on the failed steel sheet pile wall. The concrete copewall was removed from the damaged steel sheet pile and then the piles were extracted. The wharf face was braced back to existing shore bollards. The backfill that was deposited in front of the wharf structure was removed by dredge and unloaded on site.
